LAKE MONTROSE DAM

NDI ID NO. PA - 00047

KEYSTONE WATER COMPANY

PHASE I INSPECTION REPORT  
NATIONAL DAM INSPECTION PROGRAM

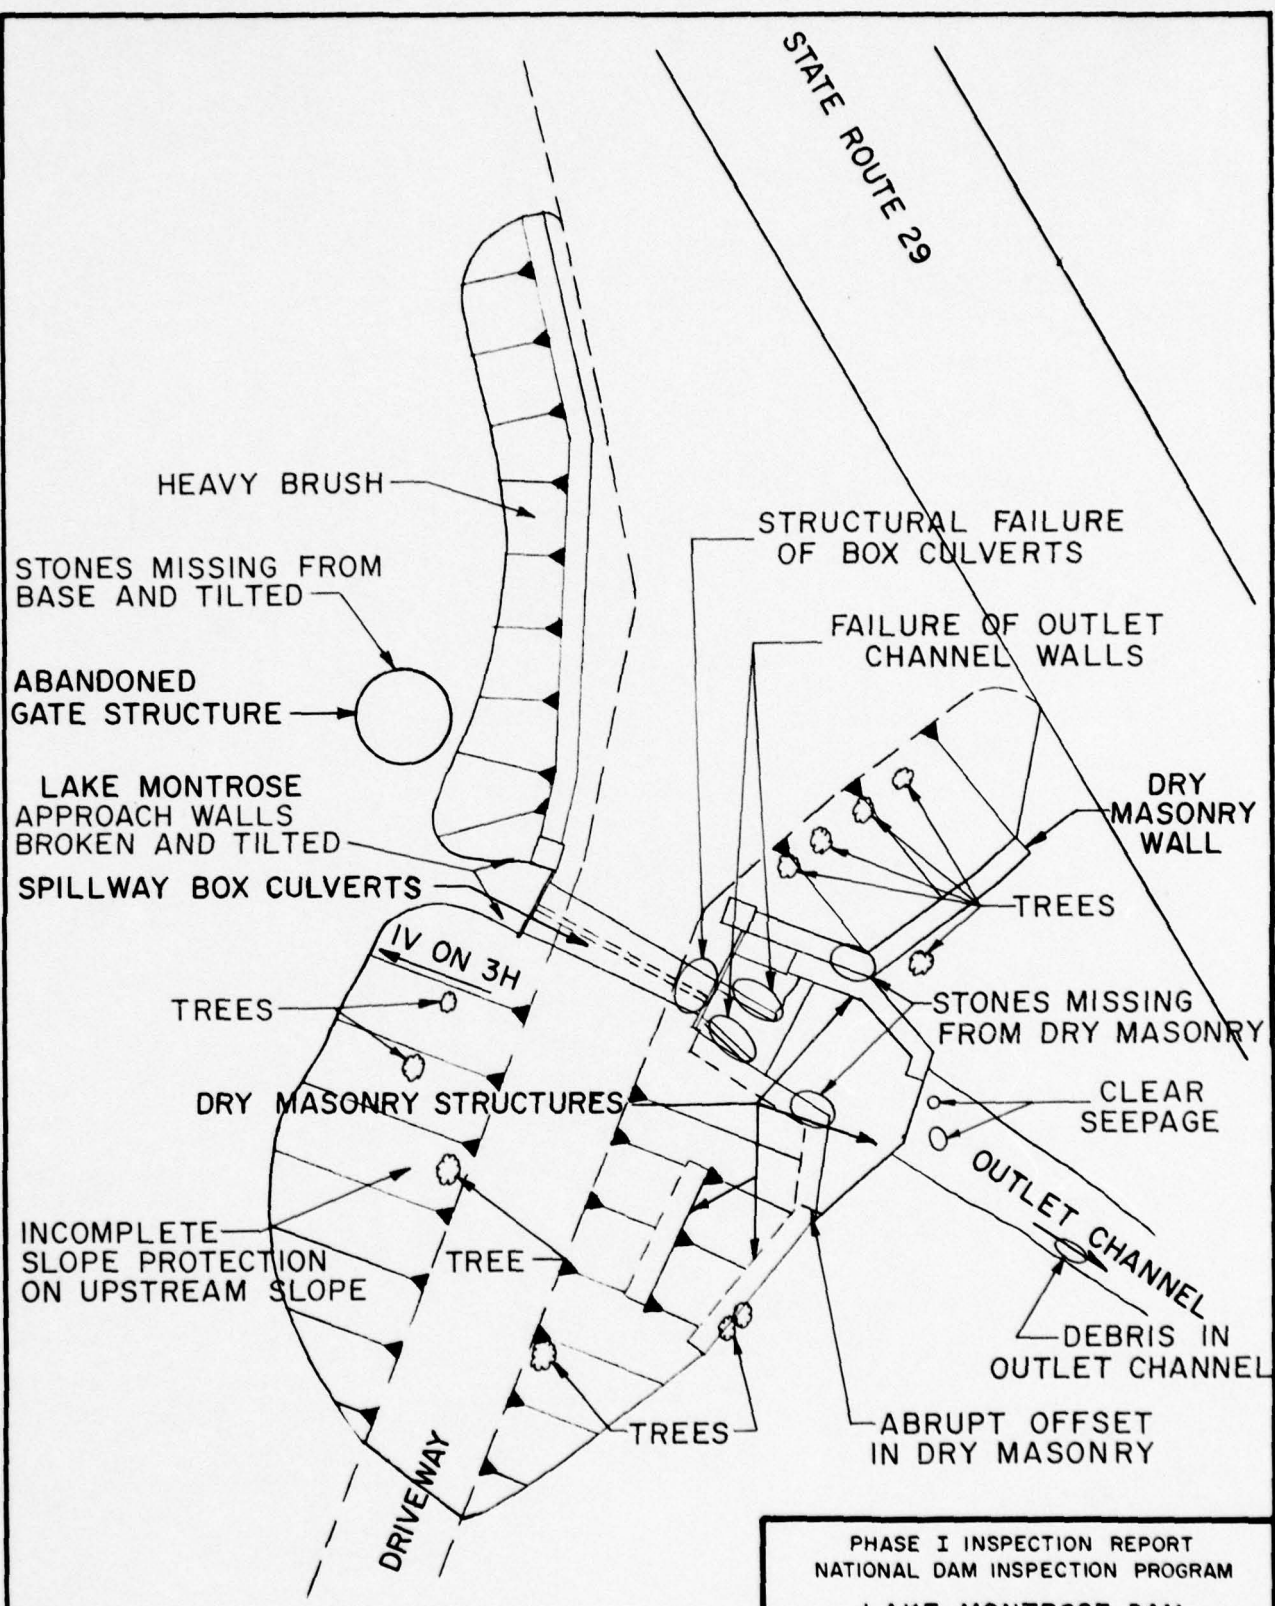
PHASE I INSPECTION REPORT  
NATIONAL DAM INSPECTION PROGRAM  
LAKE MONTROSE DAM  
KEYSTONE WATER COMPANY  
RESULTS OF VISUAL INSPECTION  
AUGUST 1979  
PLATE B-1

a. General. The overall appearance of the dam is poor, with deficiencies as noted herein. The locations of deficiencies are shown in Appendix B on Plate B-1. Survey data acquired during this inspection are presented in Appendix B. Datum for the survey was based on an assumed elevation for the spillway crest, El. 1580.0. The basis for the assumed elevation was the pool elevation shown on the USGS map. On the day of the inspection, the pool was 0.3 foot below the spillway crest.

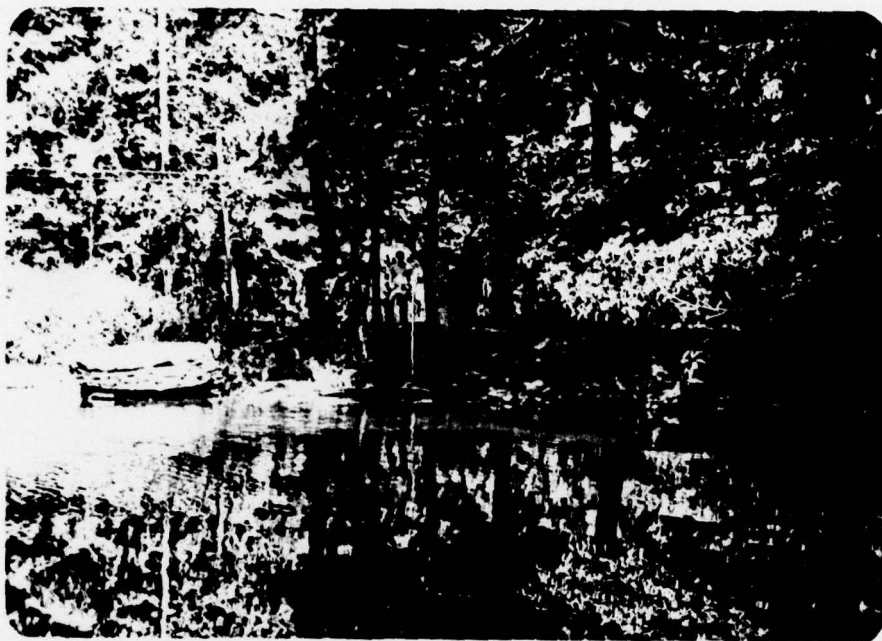
A. Upstream Slope of Embankment.

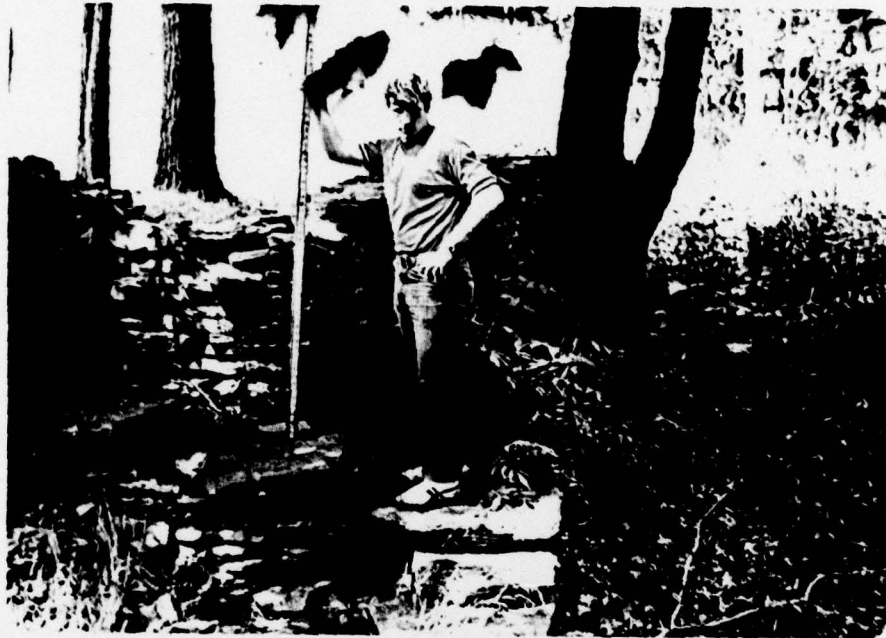
c. Dry Masonry Structure. The downstream portion of the dam is a dry masonry structure (Photographs C,D,E, and F). The portion to the left of the spillway was generally in good condition (Photograph C), except that some stones were missing and a large tree was growing at the toe. The dry masonry in the vicinity of the spillway was in poor condition (Photographs D,E, and F). Many stones were displaced or missing (Photographs D and E). Clear seepage was observed at two locations at the toe of the dam in the vicinity of the spillway. The total seepage was estimated to be approximately 3 gallons per minute. The dry masonry section located to the right of the spillway appeared to be in fair

C. Dry Masonry Structure at Left Abutment.

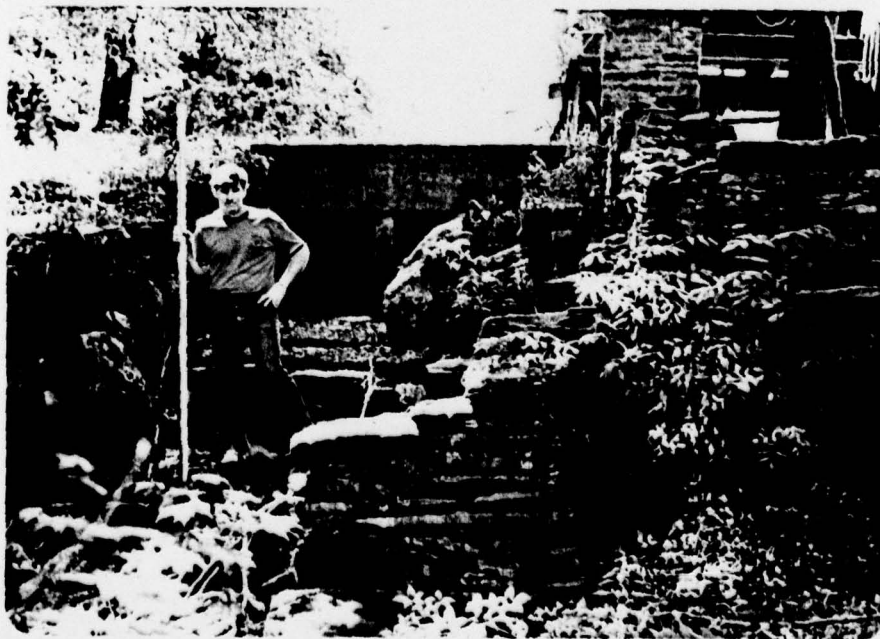
D. Dry Masonry Structure at Spillway.

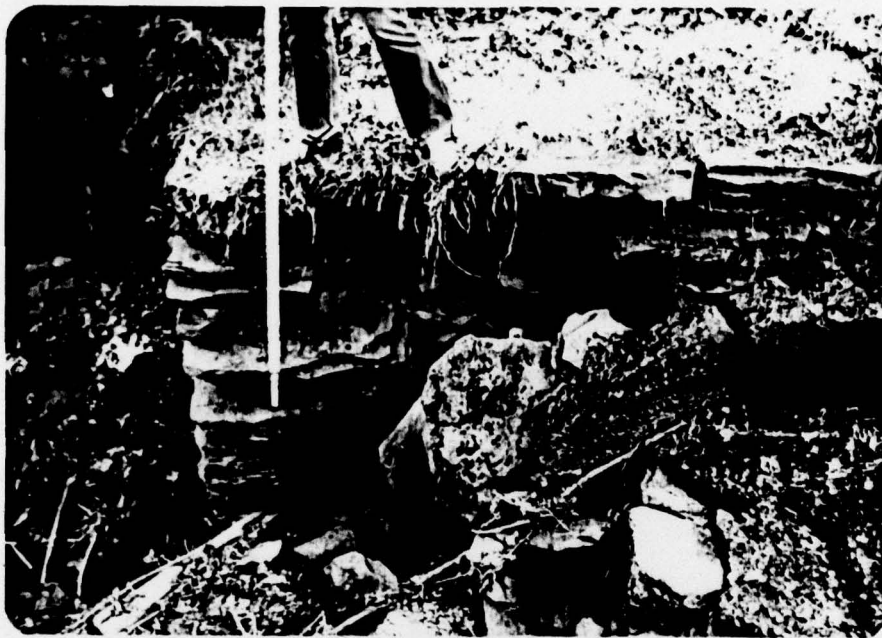
E. Dry Masonry Structure at Spillway.

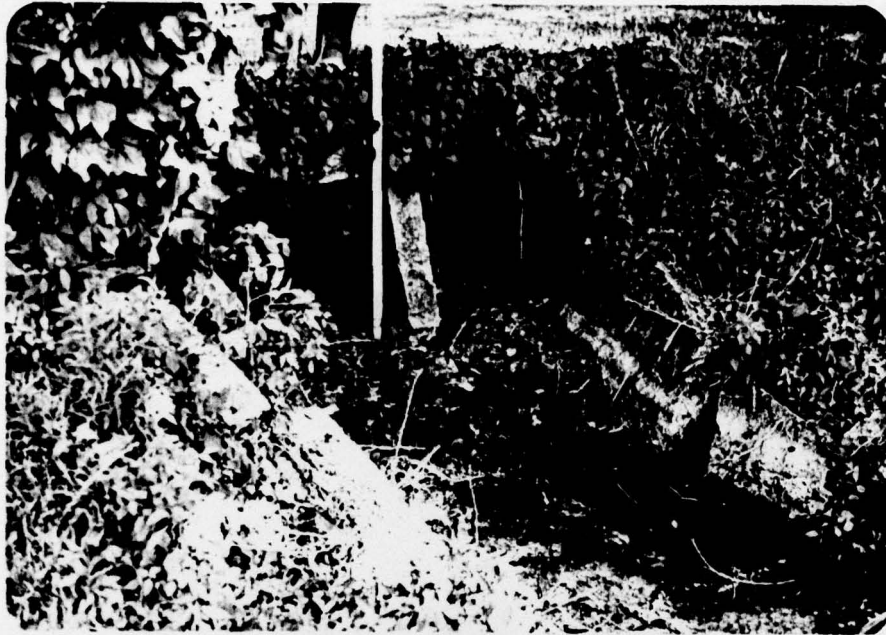
d. Appurtenant Structures. The spillway consists of a twin box culvert (Photographs G and H). The culvert serves as a bridge for the driveway across the top of the dam. Low approach walls are located at the upstream end of the spillway (Photograph G), and they were broken and tilted. The outer walls of the culvert have been displaced inward, so that the culvert openings become smaller toward the downstream end (Photographs H and J). Dimensions at each end of the culvert are presented in Appendix B. The concrete sidewalls along the culvert outlet channel are broken and tilted, and some portions are missing (Photographs H and J). The dry masonry adjacent to these sidewalls has been displaced.

G. Spillway Box Culverts at Upstream End.

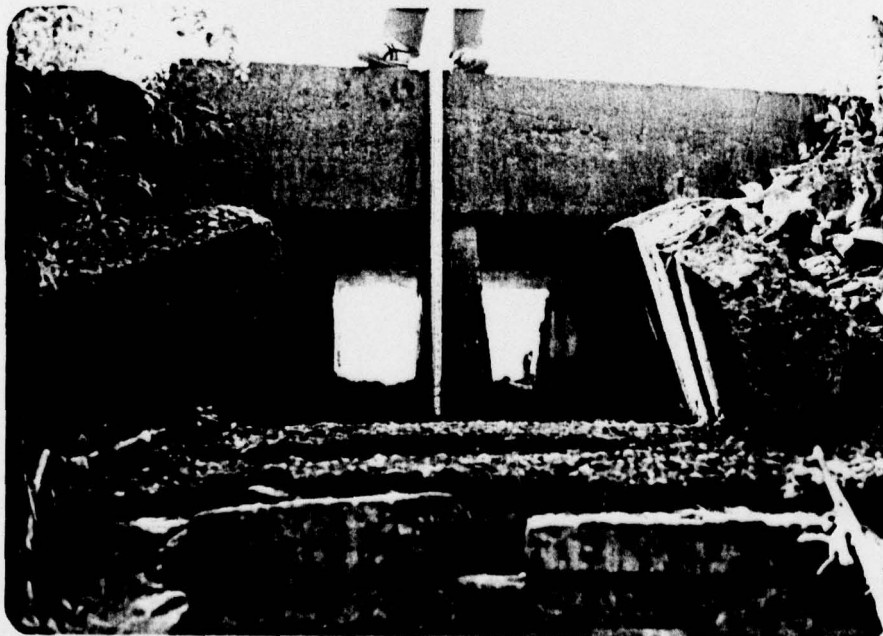
H. Spillway Box Culverts at Downstream End.

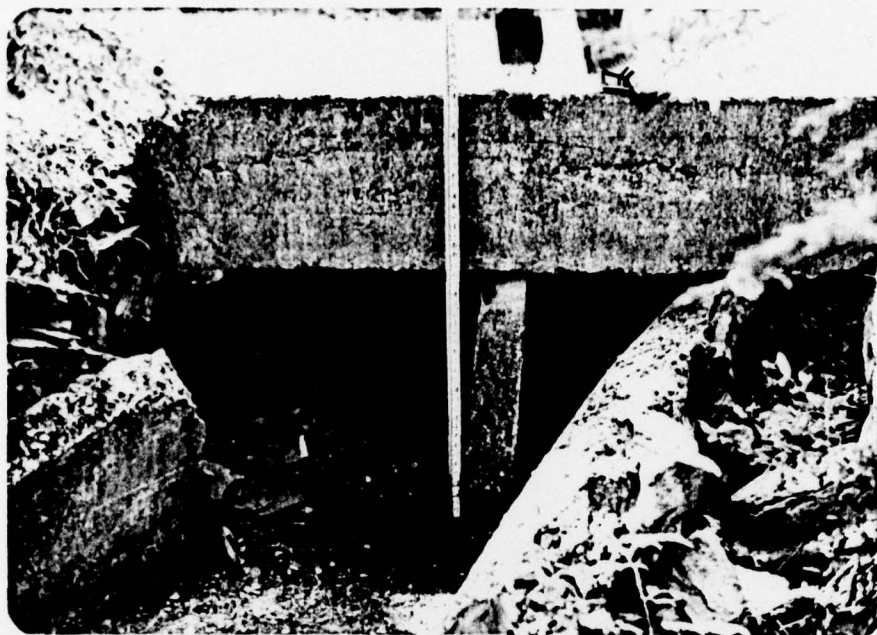
J. Spillway Box Culverts at Downstream End.

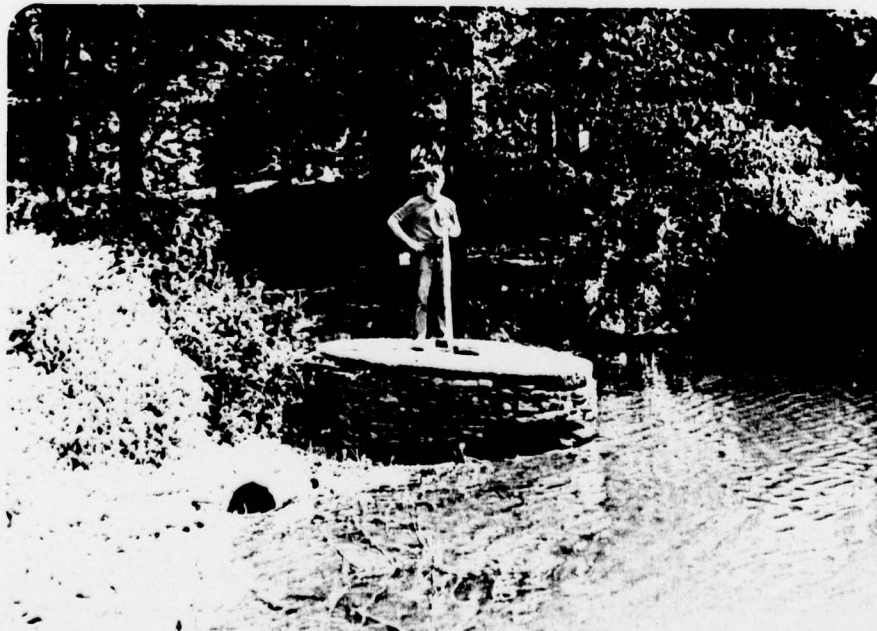
An abandoned intake structure for the outlet works is located along the upstream slope of the dam (Photograph K). The structure had stones missing from its base, and it was tilted. No evidence of an operating mechanism or an outlet conduit was visible at the intake structure. Similarly, no conduit outlet was visible on the downstream side of the dam.

K. Abandoned Intake Structure.
